2 LAKE STONEYCREEK DAM

(NDI I.D. NO: 227)

4 PHASE I INSPECTION REPORT  
NATIONAL DAM INSPECTION PROGRAM

National Dam Inspection Program. Lake  
Stoney Creek Dam (NDI ID Number 227), Ohio  
River Basin, Rhoads Creek, Somerset  
County, Pennsylvania. Phase I Inspection  
Report.

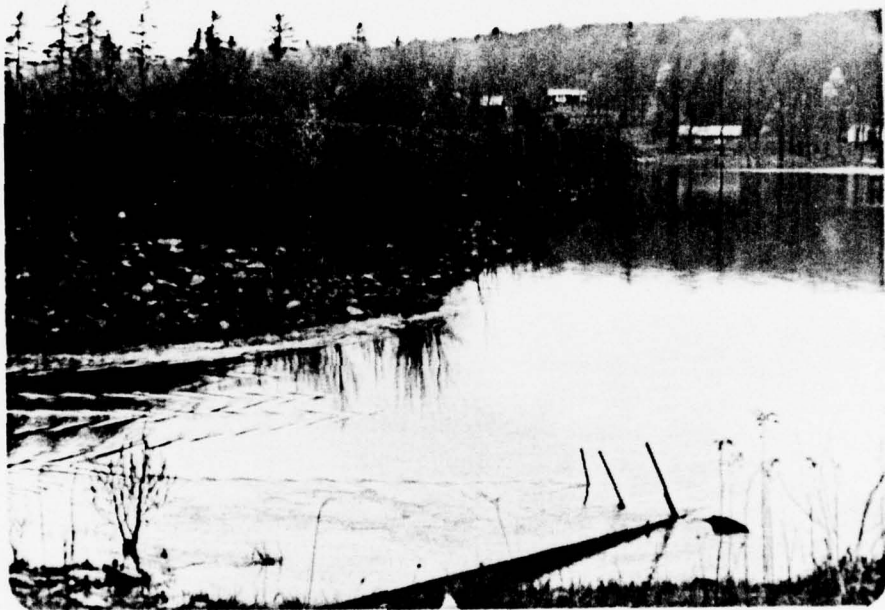
Upstream Face

4.2 Maintenance of the Dam. The maintenance condition of the dam is fair. The upstream face of the dam was covered with patches of brush and trees from 5 to 8 feet high. There is no formal dam tender responsible for the maintenance of the dam.

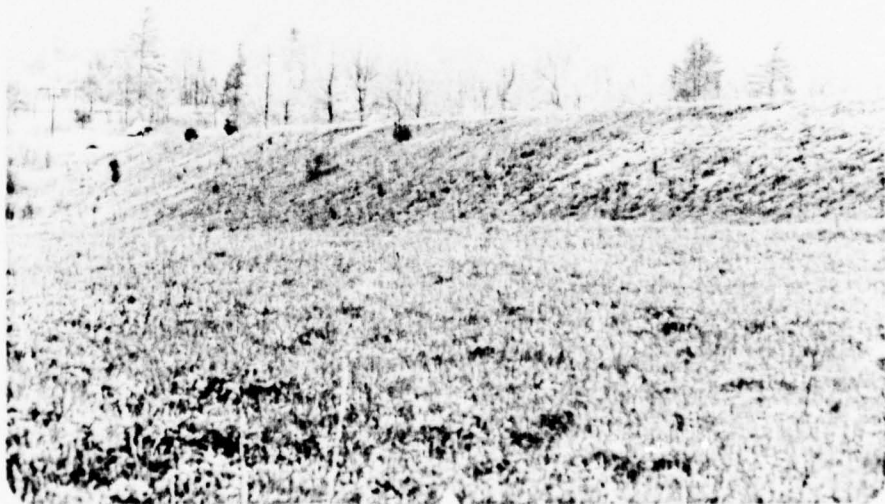
Downstream Face

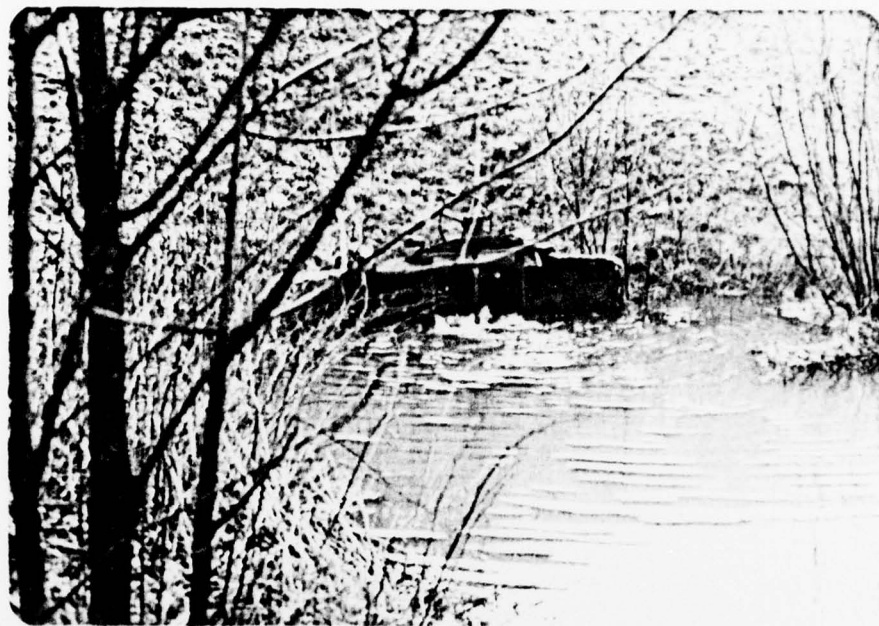
The drainpipe valve was operated and found to be functional. However, significant leakage around the gate was observed, indicating that the sluice gate is not properly seated.

4.3 Maintenance of Operating Facilities. The only operational feature of the dam is the drainpipe gate. On the date of inspection it was operated and found to be functional. However, significant leakage was observed between the gate and gate guide, indicating that the sluice gate is not adequately seated.

Photograph No. 7  
Blow-off pipe valve (opened for inspection).
